Subject: Condition report for Picasso painting.

Title: “Tete de taureau et broc”

Artist: Pablo Picasso (Spanish 1881-1973)

UPDATE: 2025 examination results- Homage to Picasso Still Life painting

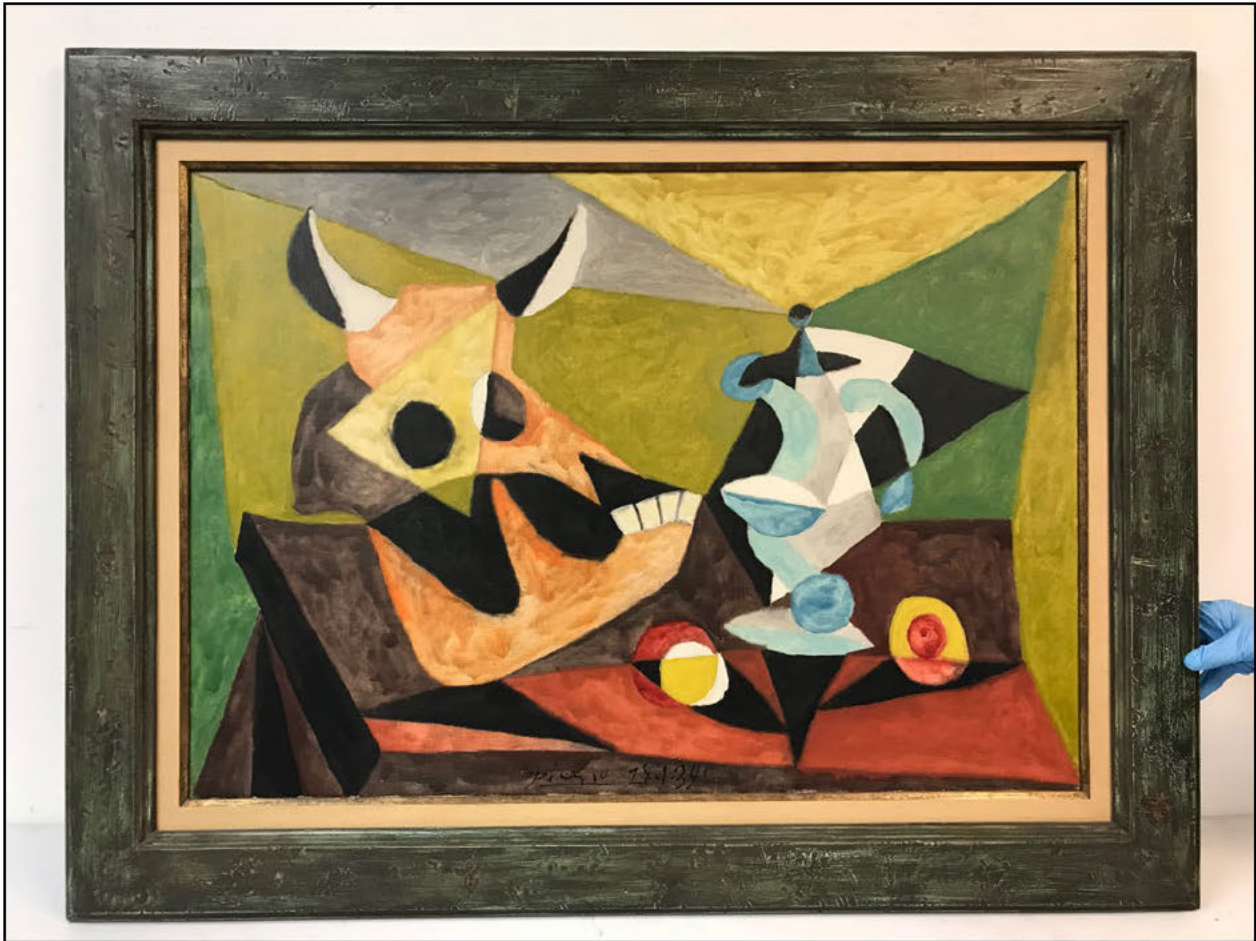
Supporting images:
Figure 1: "Tete de taureau et broc" Pablo Picasso 1939.

The canvas support is very slightly puckered near the viewer's left side.

The paint layer is covered with a relatively thick layer of varnish of unknown composition. This varnish has slightly discolored over time but does not appear to affect the overall color balance of the design.

The paint layer is intact, stable showing no signs of damage or former repairs. No age-related effects such as craquelure of either the varnish or the paint layer are visible.

With the exception noted above regarding the state of the tacking margins, the design layer, the painting itself is in good condition at this time.

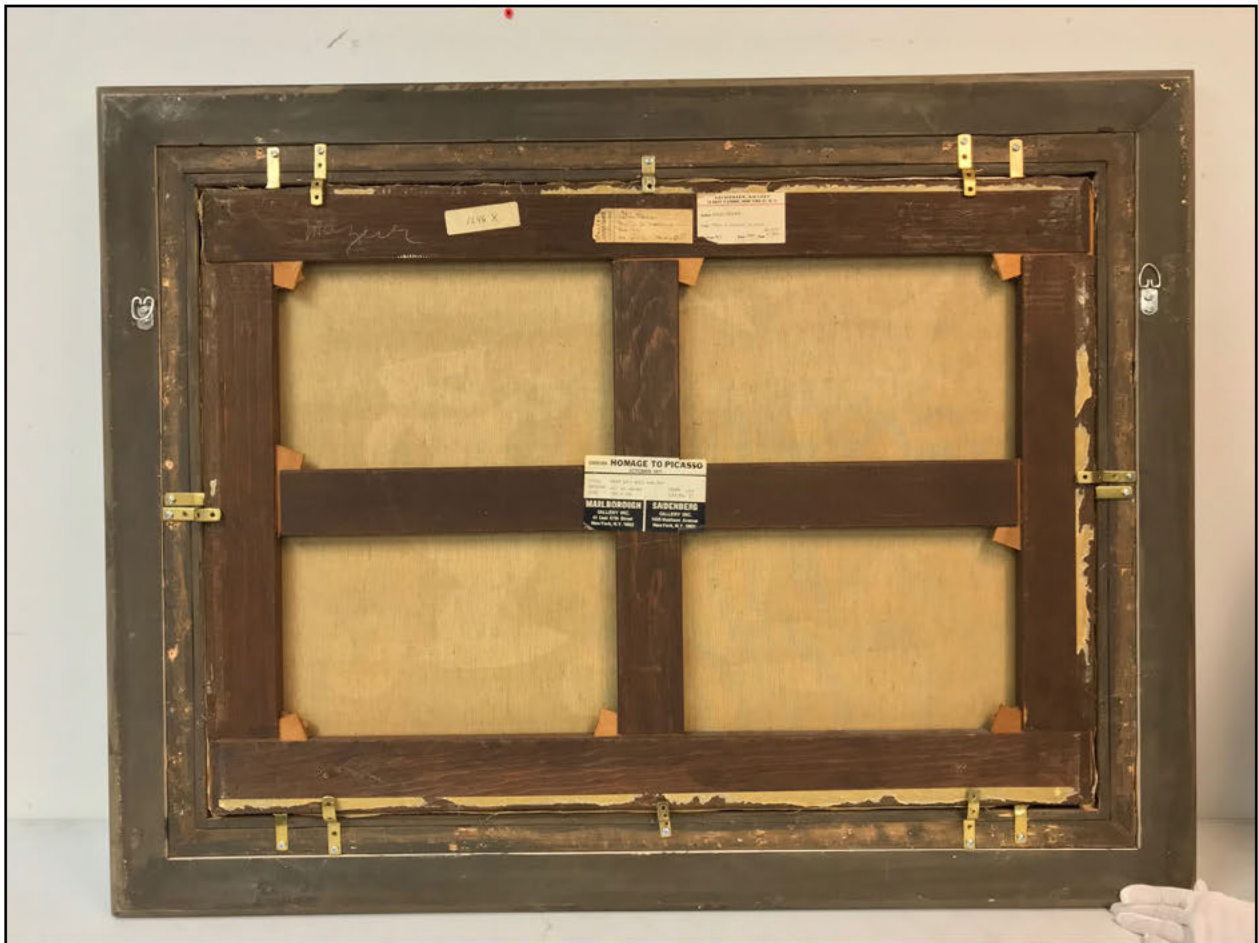
Figure 2: Verso of Picasso painting.

The original wooden stretcher system may have been replaced at some time in the past, (or the painting removed and reattached to the stretchers). No documentation of this treatment was seen but the tacking margins show missing tacks and two different spacings of the stacks.

The former (missing) spacing about 3-inch intervals, the current spacing about 1.5-inch intervals. The present wooden stretcher system consists of 3” x 3/4” (WxH) outside bars with 2 1/4” x 3/4” (WxH) wooden bracing in the form of a cross. The present system has a total of 12 pre-cut slots which hold hardwood “keys” that (when tapped into the slots) allow for expansion and tensioning of the canvas support.

The verso contains (3) paper, gallery-exhibition labels (see supporting images), a separate numbered label and a handwritten pencil inscription "Mazur." All these labels are attached to the verso of the stretcher bars.

Under no circumstances should the artwork be tensioned further at this time; (i.e. through 'tapping' the wooden stretcher "keys").

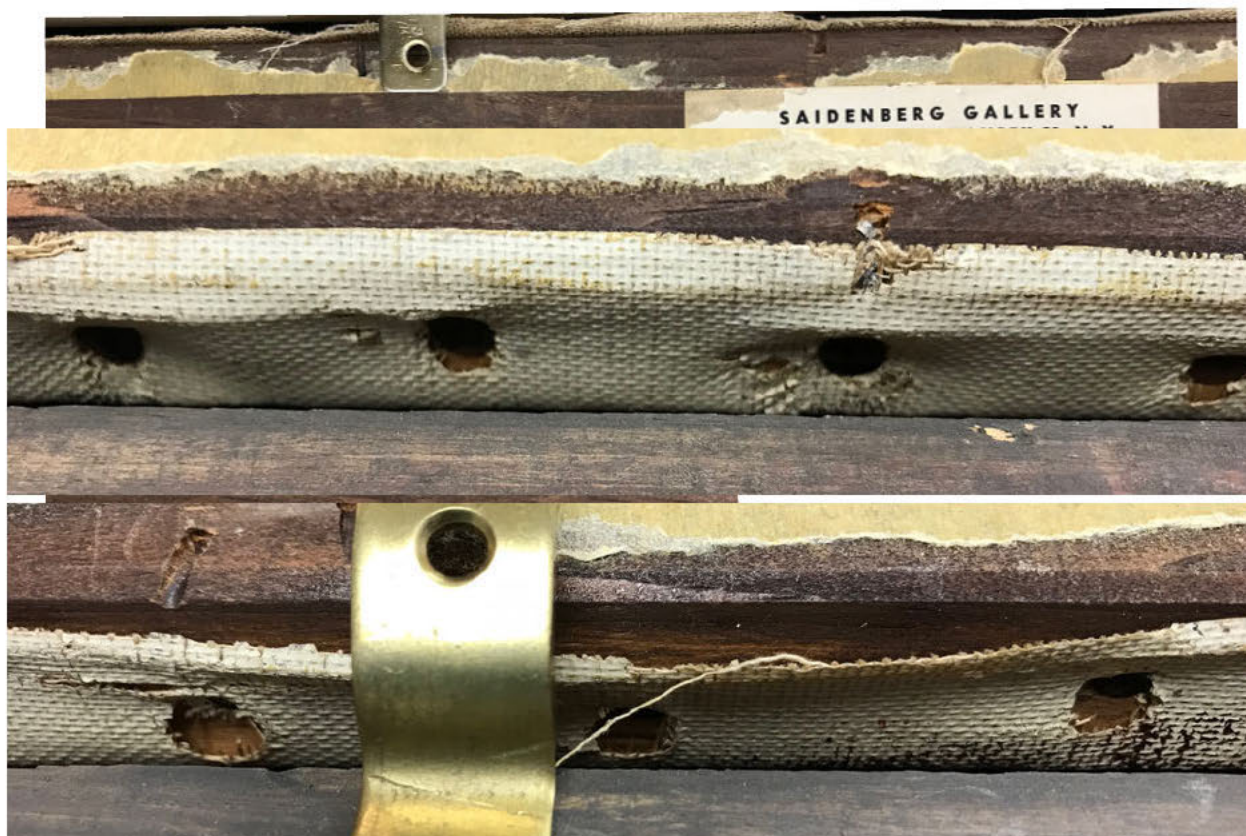
Figures 7-9: Left tacking margin (as seen from verso):

The painting has been re-tensioned (probably at the same time the stretchers were replaced). The re-tensioning coupled with the relatively brittle state of the fabric support along the tacking margins are believed responsible for the degraded state of the tacking margins that have resulted in numerous tacks separating from the canvas support.

The present state of the tacking margins in the above respect (separating from the attachment tacks) represents a significant risk to the artwork in the form of potential detachment of the entire artwork along at least one or more edges.

The relatively poor physical condition of the tacking margins is reemphasized.

While reinforcement of a tacking margin is a relatively straightforward conservation procedure, in this case the condition of the fabric support (aged, thin) should be carefully weighed against the potential impact on the value of the artwork before an appropriate treatment is chosen.

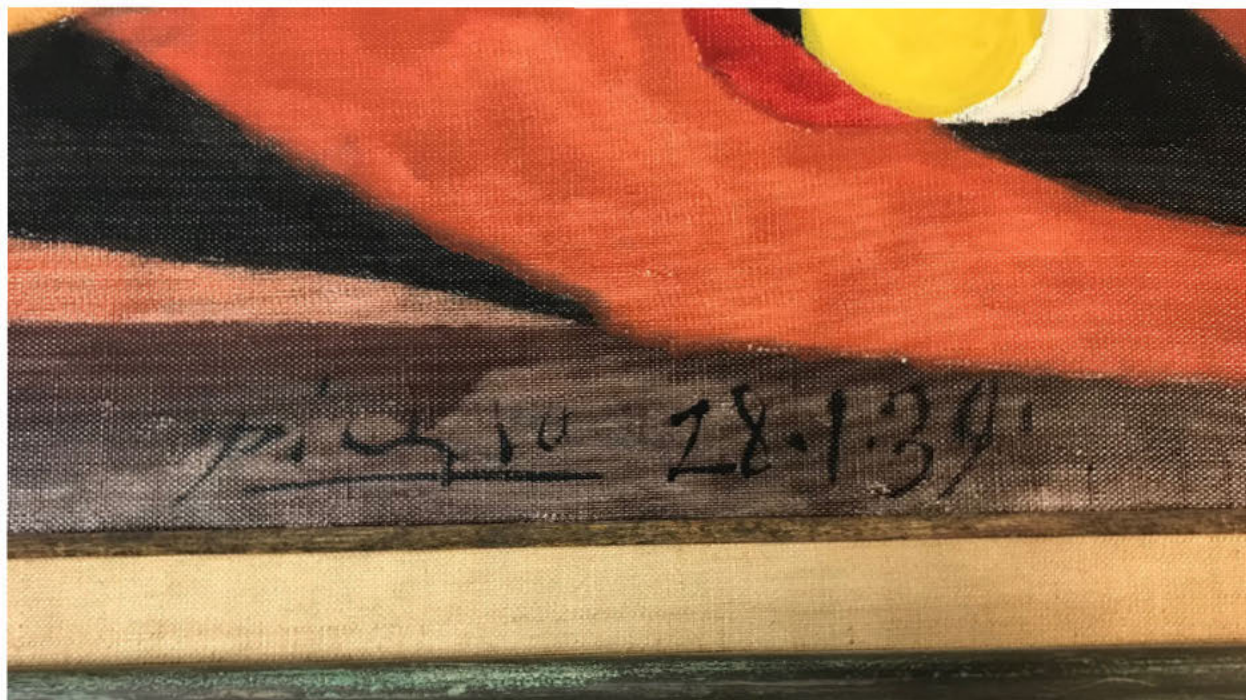
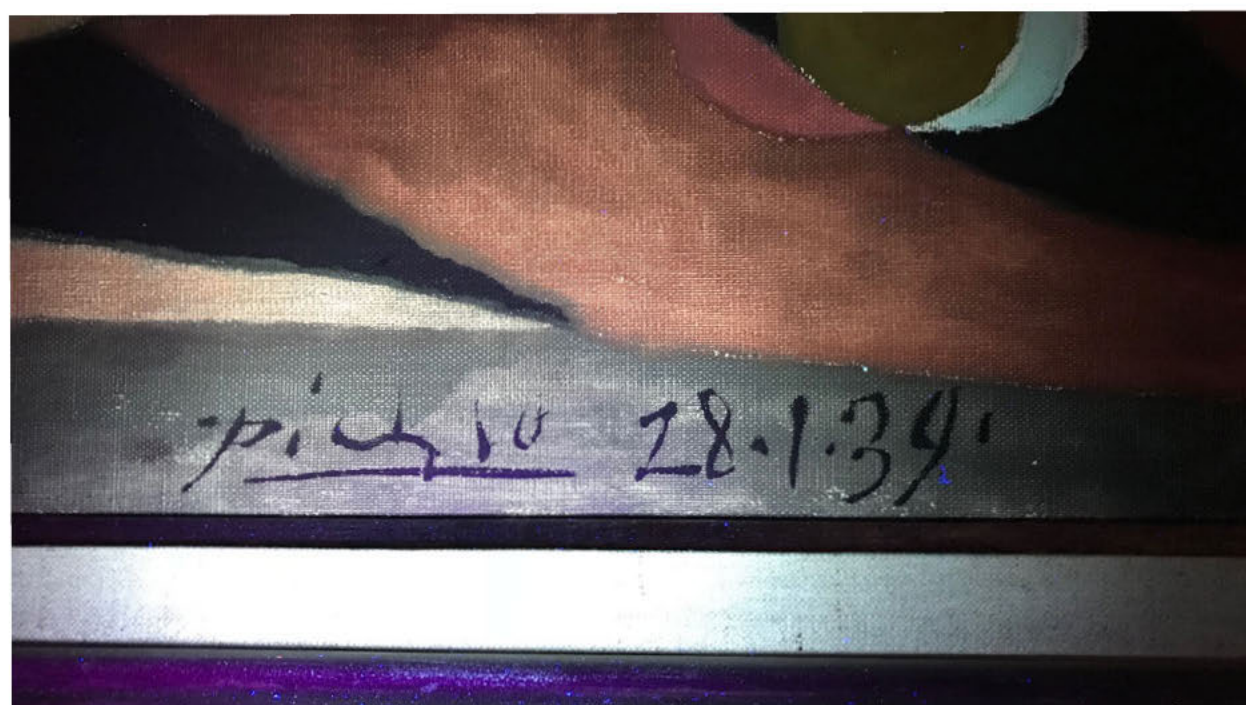
Figures 13-14: Signature under normal room lighting (above) and UV flood lamp (below).

The painting was examined under UV flood lamp lighting. No signs of touch-up or additions to the original design were seen under UV lighting. A single thin vertical 'crack' (about 1 inch in length) in the paint layer is visible under UV light. This tiny fissure does not affect the integrity of the artwork, does not require conservation intervention and is not visible under normal room lighting.

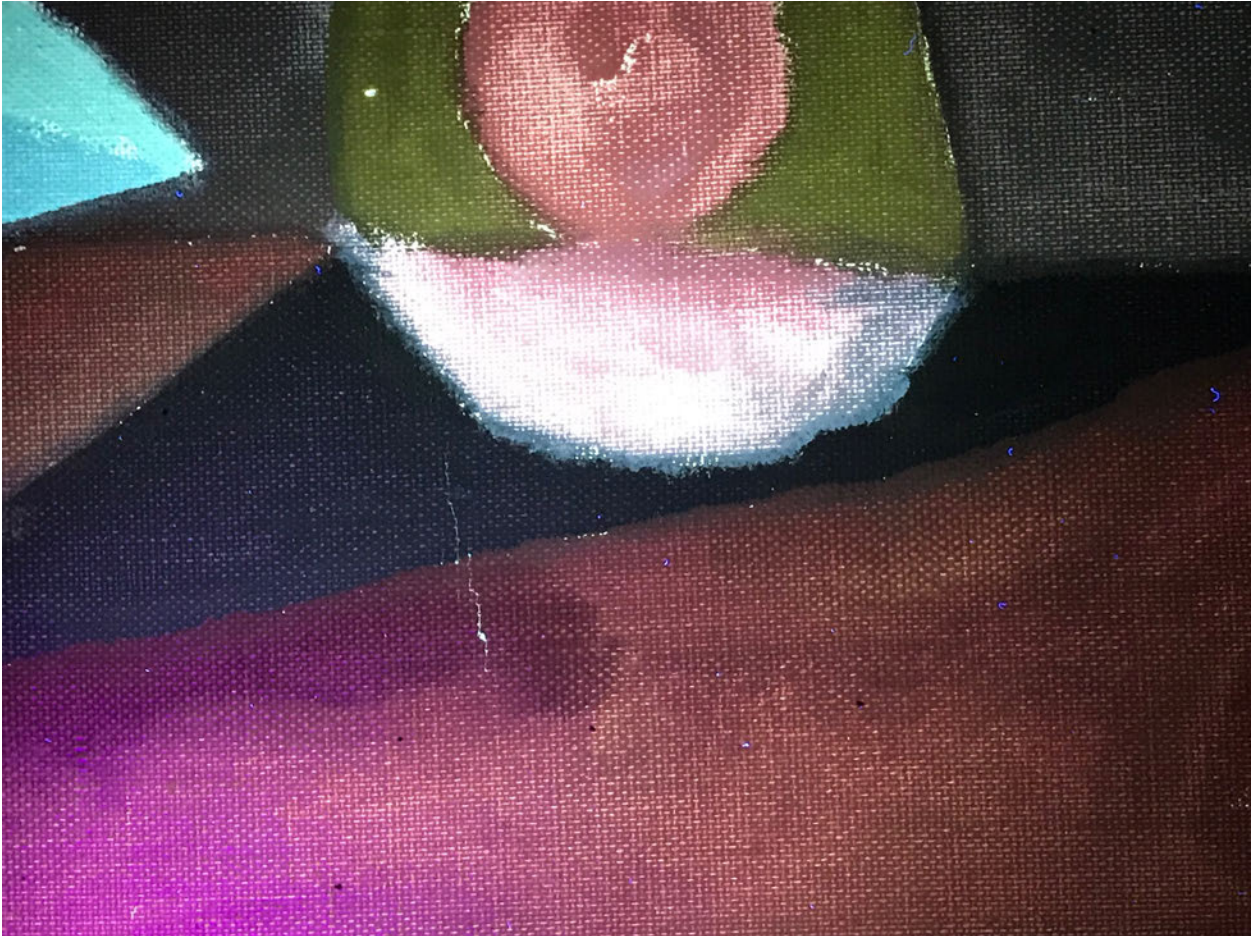
Figure 15: Tiny crack in paint layer as it appears under UV flood lamp.
